Rebuilding the Spoiler Drive worm-and-wheel gearbox

Porsche 964 & 993

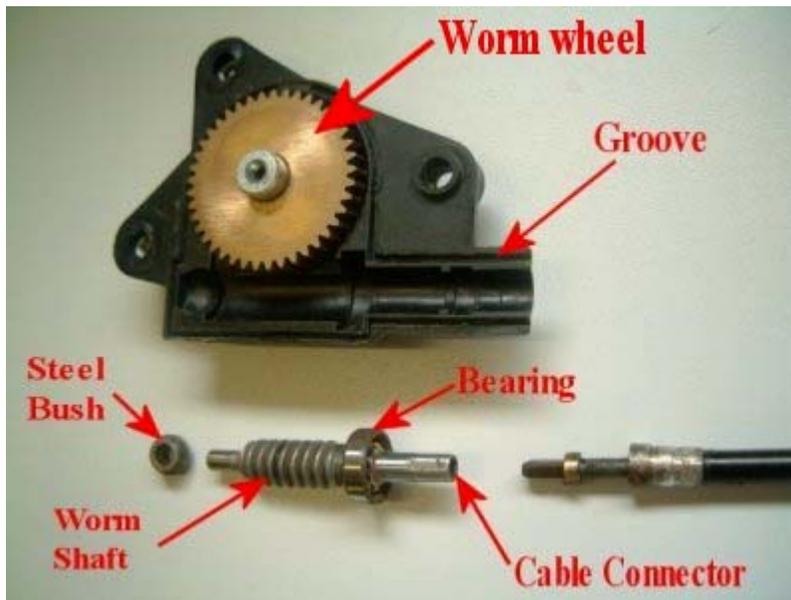
When you get it apart, wash all the old grease out with some spirit and thoroughly clean the joint. The other half of the casing has a ridge which mates with the groove shown. After cleaning the casing make sure that the two halves fit closely together. On mine the bearing had run dry, probably through lack of grease. The gearbox does not get warm enough to allow the grease to flow into the bearing, which is how this type of arrangement is supposed to work. If I were you I would not attempt to remove the worm wheel.
